**Prepared For:** Home Buyer

**Property Address:** 345 Main Street, Lancaster, PA 17603

**Inspector:** Matthew Steger  
**Company:** MWS, LLC  
dba WIN Home Inspection Elizabethtown  
(717) 361-9467  
msteger@wini.com

Standard Home Inspection

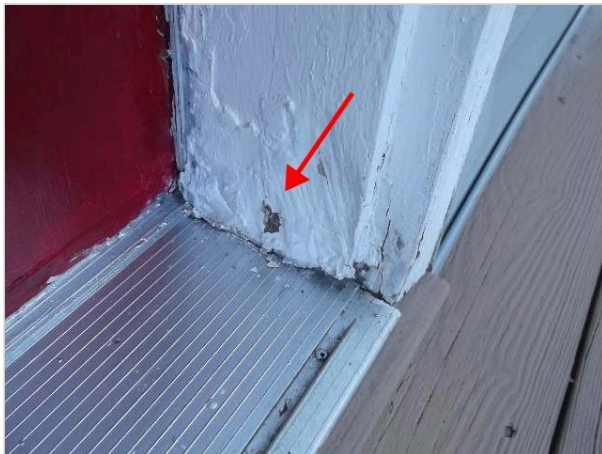
Wood rot was noted at the front door trim. Repair of the affected wood is recommended to prevent further damage. All exterior wooden surfaces should be kept well painted or capped in order to help prevent rot and insect infestation.

Rotted wood trim was noted outside the front entrance door.

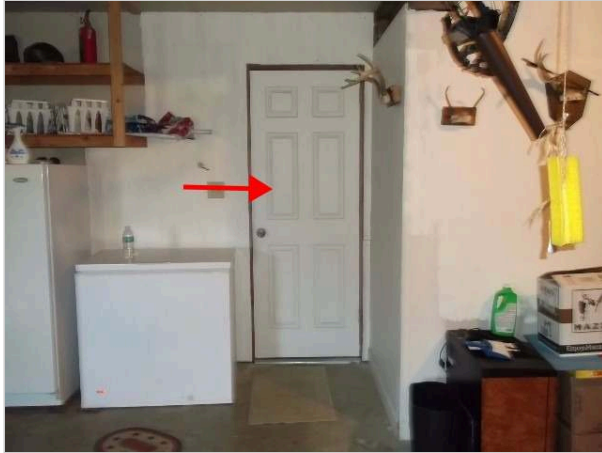
The garage mandoor into the home is not fire-rated (provides no fire-separation). A fire-rated steel or solid wood door (at least 1 3/8" thick) or other approved fire-rated assembly with no windows or other openings is recommended to help slow the spread of a possible garage fire or carbon monoxide into the home.

The garage mandoor into the home is not fire-rated.

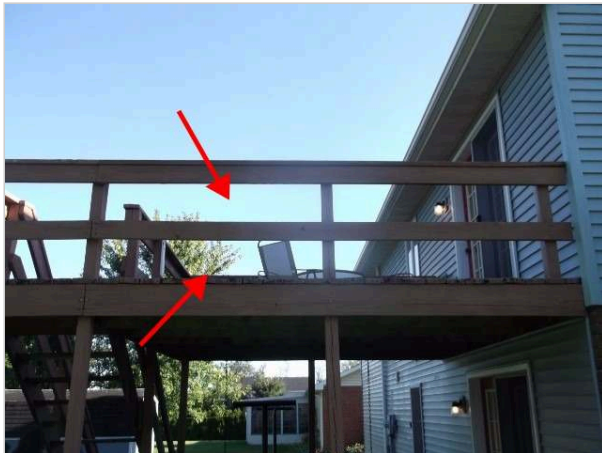
The guard railing has only horizontal rails installed between the main rail supports. This can allow a child to climb the railings (like a ladder) and potentially fall over the other side. Also, the guard railings are only 30" high. Modern construction standards call for guard railings be constructed with no openings wider than 4" within or below and their height should be at least 36". Short railings may not prevent an adult from falling over them. Repair is recommended as a preventive safety measure.

Deck's guard railings are climbable by a small child.

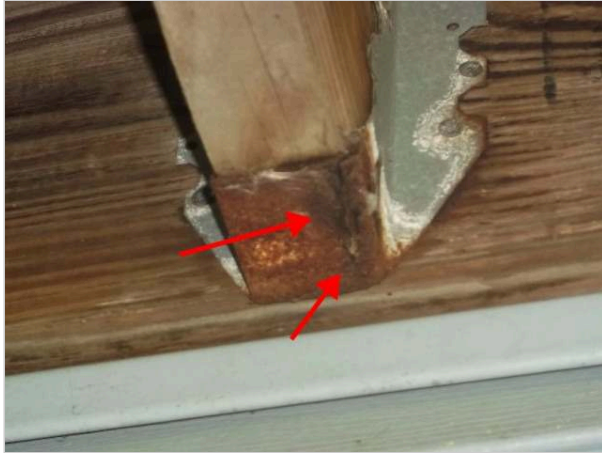
The inspector noted a rusted and cracked joist hanger at the deck's NE corner. This could allow the joist fail which could compromise the deck structure. Repair by a qualified deck contractor is recommended.

Deck's NE corner joist hanger is rusted and cracked.

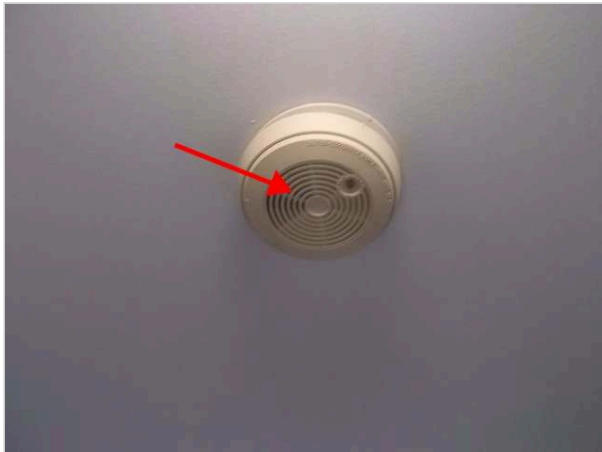
Accessible smoke detectors are tested for power only; they are not tested for the detection of smoke/fire. The installed smoke detectors appear to be more than 10 years old (likely original). Replacing the smoke detectors is recommended for safety reasons. Smoke detectors should be tested for power on a monthly basis and should be replaced after 10 years of service. Underwriters Laboratory (UL) approved photoelectric and ionization type smoke detectors are recommended on each level of the structure and in each bedroom for increased safety. For more info, see: <http://elizabethtown.wini.com/resources/tech-articles/smoke-detectors/>

The installed smoke detectors are more than 10 years old (original) and should be replaced.

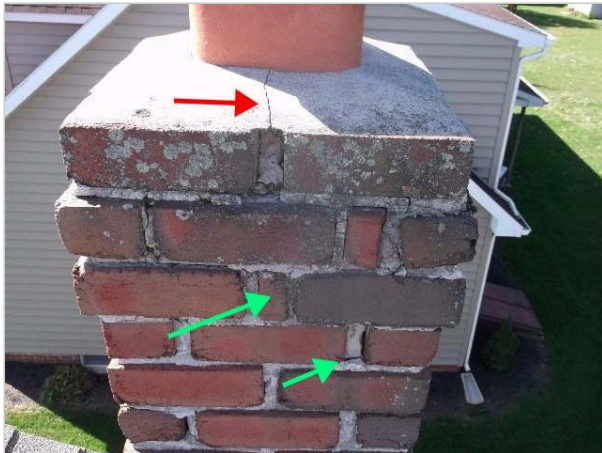
Some minor chimney masonry deterioration was noted. Repair and a level 2 chimney cleaning/inspection by a qualified chimney professional is recommended prior to closing. Most of the chimney (including its interior) is not visible during a home inspection. Industry standards also recommend a clean/service annually with use. A compromised chimney/flue can also allow exhaust gases or water into the home.

Some minor cracking and mortar deterioration were noted at the chimney.
