**Property Address:** 1233 Main St., Lancaster, PA 17603

**Inspector:** Matthew Steger  
**Company:** MWS, LLC  
dba WIN Home Inspection Elizabethtown  
(717) 361-9467  
msteger@wini.com

Extended Inspection

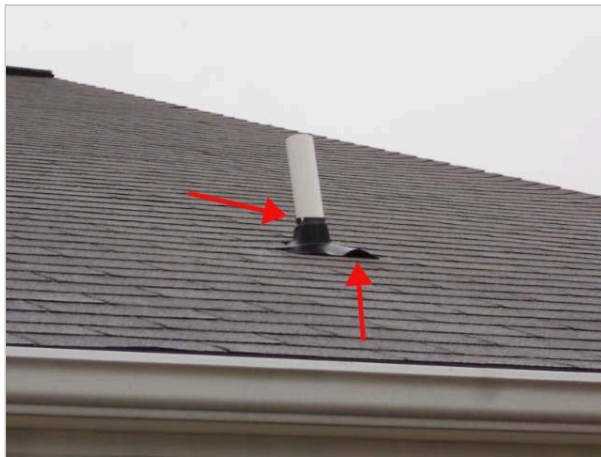
The inspector noted a torn stack vent's rubber boot at the rear main roof. The tear can allow for water entry into the structure. Repair is recommended by a qualified roofer.

A partially torn and lifted boot was noted at the main roof's SE corner plumbing stack vent.

Caulking/flashing around the roof penetrations (such as stack vent boots, roof vents, etc.) should be inspected at least twice per year. Most roof flashing is covered by roof and siding materials and not visible after installation. Roof leaks are a common and yet avoidable condition often due to deteriorated flashing and caulking. The cost and time involved in upkeep is minimal as long as it is maintained on a bi-annual basis.

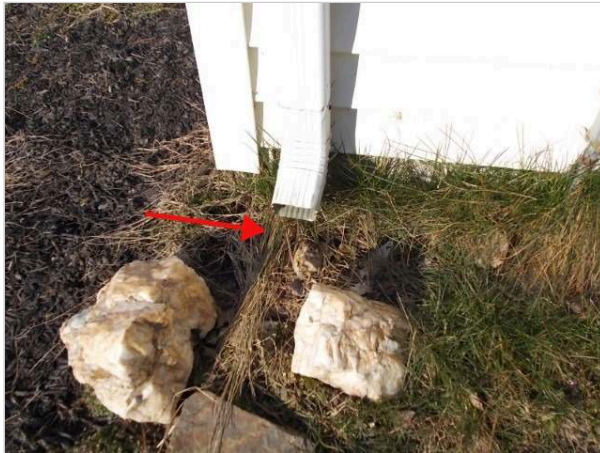
One or more downspouts discharge along the foundation. This is a common cause for wet basements, insect/rodent infestation, wood rot, and foundation issues. Downspouts should drain at least 4' from the foundation to help facilitate water flow away from the structure. Repair is recommended.

Multiple downspouts discharge along the home's foundation.

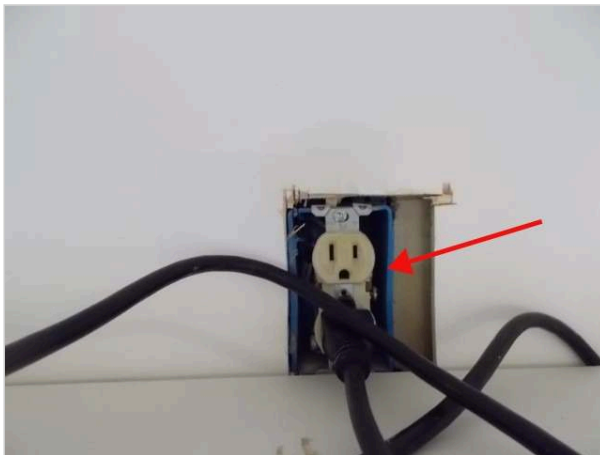
A kitchen receptacle to the left of the kitchen sink is missing a cover plate. This presents a potential safety hazard. All switches and receptacles should have proper cover plates installed. Repair is recommended.

Kitchen counter receptacle (to the left of the sink) is missing a receptacle cover plate.

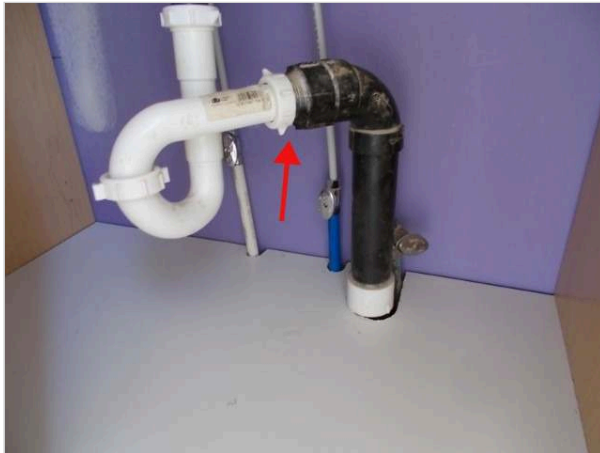
The inspector has found plumbing leaks under the master bathroom's sink and on the dining room ceiling (near the ceiling fan). The dining room ceiling leak appears to be directly below the master bathroom's shower stall. This leak was found initially using an infrared camera and the leak area was confirmed to be saturated (100% moisture content) using a moisture meter. Consulting a licensed and qualified plumber is recommended for repair.

Leak was noted at the master bathroom sink's drain pipe.

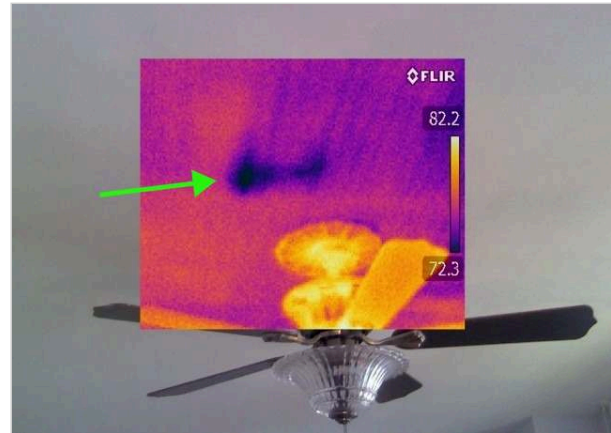
Active leak was noted on the dining room ceiling below the master bathroom's shower stall.

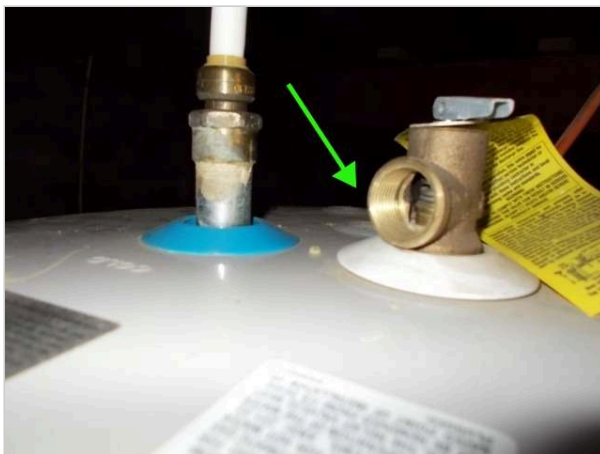
There is no discharge pipe connected to the hot water tank's T&P relief valve. An approved hot water-rated pipe (such as copper) should be connected to the temperature and pressure (T&P) relief valve and extended to approximately 6" above the floor to help prevent accidental scalding in the event that the T&P valve discharges. Consult a licensed plumber for repair.

The water heater's T&P valve lacks its required discharge pipe.

PVC is not a hot water-approved pipe material and should not be used as a T&P overflow discharge pipe. The discharge pipe must be no smaller in diameter than the relief valve and must not be threaded at the bottom (to prevent someone from capping it).
